CVE MONITOR®

Progressive's CVE Monitor tracks tool activity, allowing users to view data on the display or from comprehensive reports using OnDemand or the new CVE Live System. Features include:

CVE ONDEMAND®

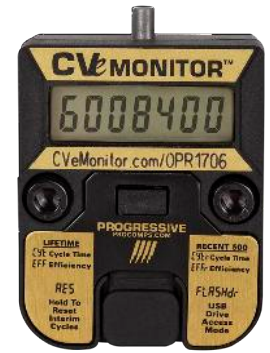
- 7-digit LCD display with a push button to move through the display modes.
- 16GB flash drive for file storage.
- Replaceable battery.
- Water resistant with an ingress protection rating of IP58.
- Maximum temperature: 190° F (90° C). For heat protection, refer to the Insulators available on pages F-10 and F-11.
- Recommended mounting is on the stationary half of the mold.
- Dimensional compatibility with Progressive's mechanical CounterViews.
- Mini USB connectivity for data retrieval with cables sold separately.

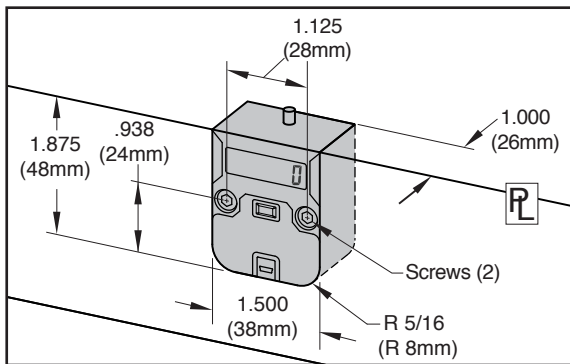
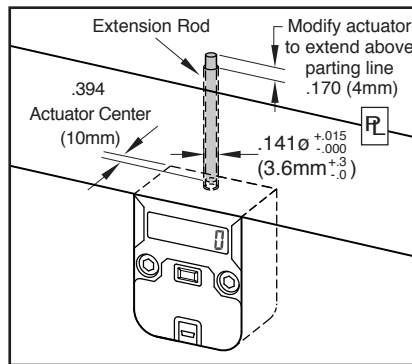
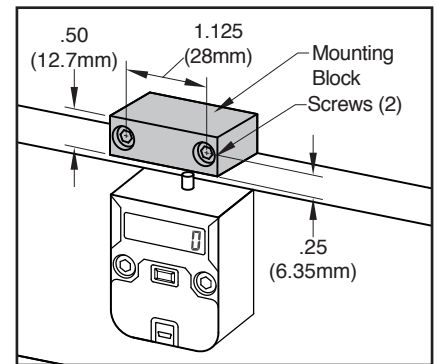
MOUNTING OPTIONS

- For installation below parting line (ie. rails as shown in the center graphic above), order (1) CVE and (1) CVE-INT.
- For installation outside of the mold (right graphic), order (1) CVE and (1) CVE-EXT.

CATALOG NUMBER	DESCRIPTION
CVE-INT	Internal Extension Rod (8"/200mm)
CVE-EXT	External Mounting Block including #8-32 x 1" SHCS (2) and M4 x 25mm SHCS (2)

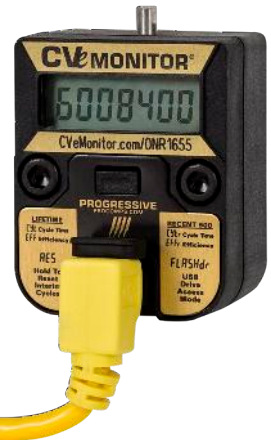
Using a USB cable, users can connect the CVE Monitor to their computer or tablet and view data in OnDemand, outlining the reason for the report generation. Notes can be included and user information is recorded for historical reference. More details about OnDemand are on the following pages.
